[RADONSEAL CRACK FILLER](#)

TESTIMONIAL

PROCEDURES & RESULTS

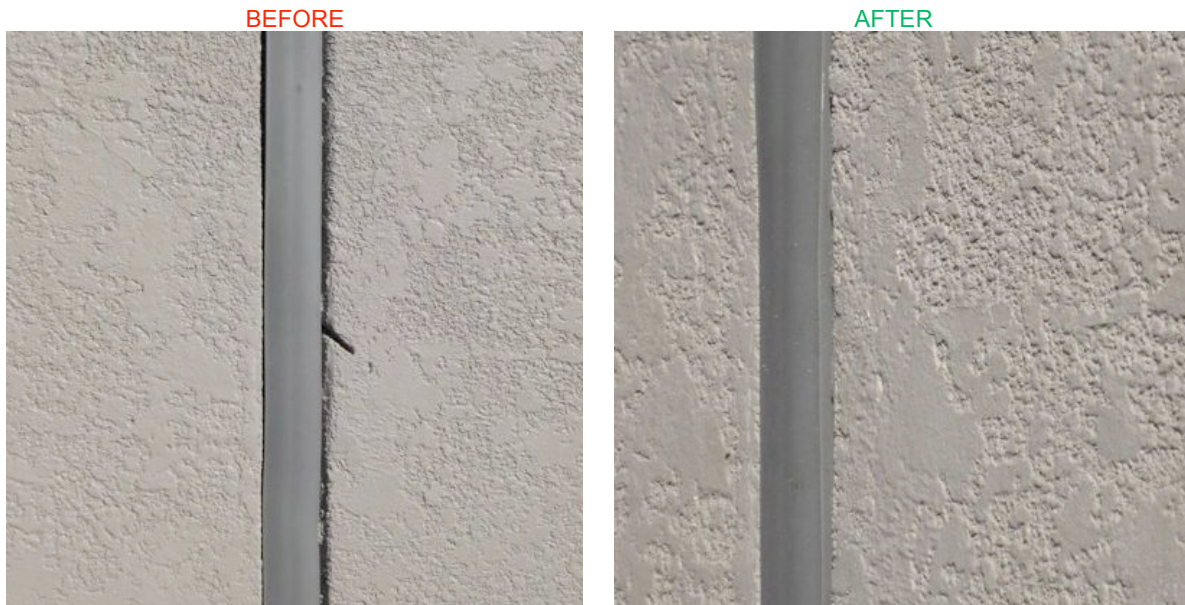
My initial repair was an errant saw cut about one (1) inch long and approximately half of the slab thickness. Utilizing the remainder of my final "test batch" with a 2:1 sand to epoxy filler mix ratio, this repair was done in minutes. The sand component was *Premium Play Sand* packaged by *SHORT MOUNTAIN SILICA* (Light Tan in color – purchased at Home Depot). All of my photos depict the final repair results, which includes one layer of my Pool Deck Coating. The next two pictures summarize this first gouge repair.

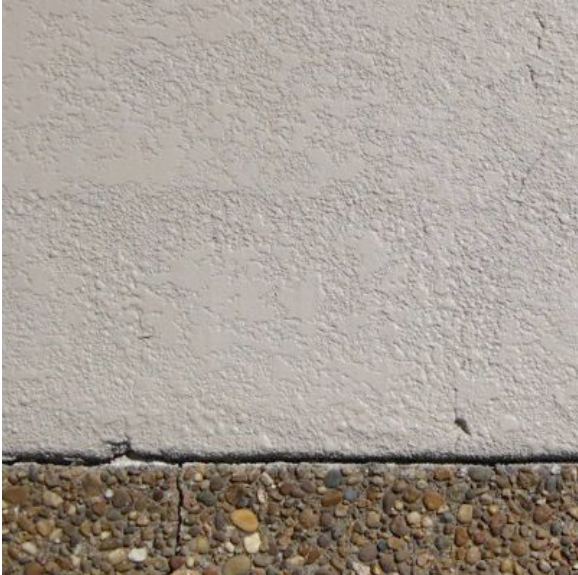
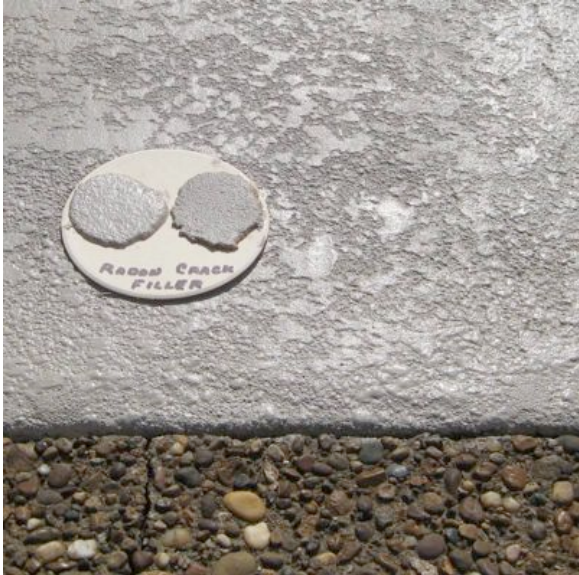
The two small repairs, shown below, were also made using the same 2:1 ratio of sand to epoxy filler mix. These two small areas were sprinkled lightly with sand, after patching, to provide additional texture. Excess sand was removed by brushing after 3 to 4 hours. The “test batch” card in the *AFTER* photo displays cured swatches of the 2:1 Sand/Epoxy Mix. The *Left Swatch* is painted with my Deck Coating; the *Right Swatch* is unpainted.

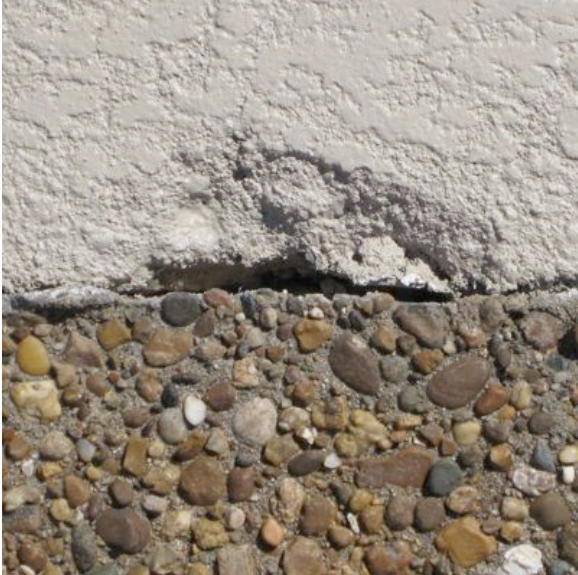
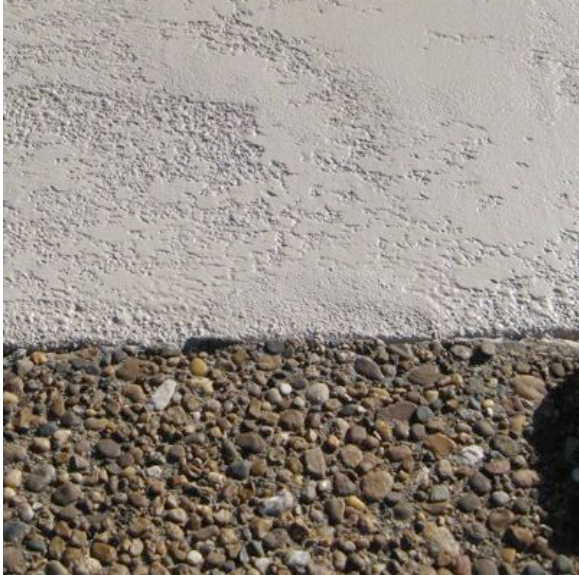
The spall shown below was also repaired using the above mixture and application procedures. There was some very slight sagging near the aggregate pad, but since the entire pool deck is greatly textured, it is virtually invisible unless one knows where the repair was made.

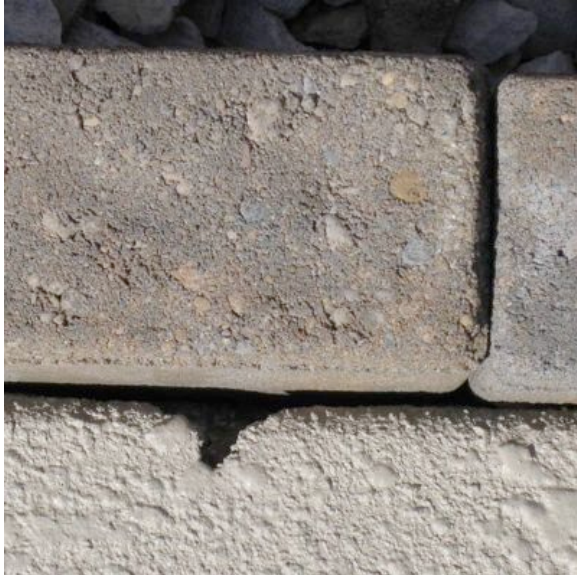
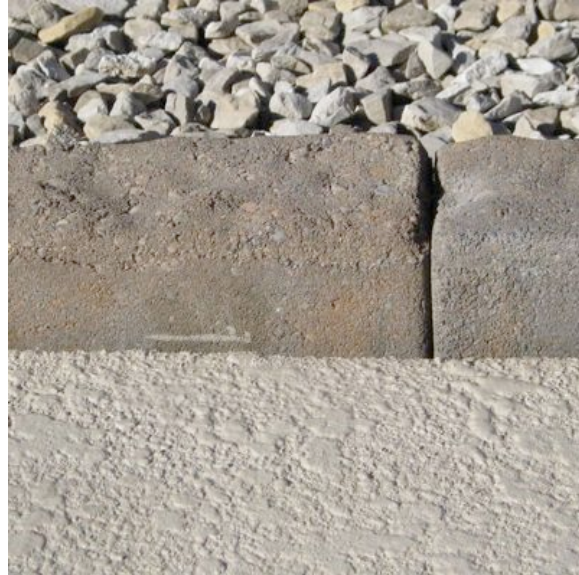
The defect below extended almost full depth of the slab and was about two (2) inches deep, horizontally, when the edger was removed. All loose material was chiseled out and a 3:1 sand to epoxy filler mix was packed into this void leaving only what can be seen in the *BEFORE* photo. This remaining area was filled as above, retooling after ½ hour to correct minor sagging. Only the *BEFORE* photograph and the edger position allowed me to find the repaired area for painting. After painting, the final photo depicts the fruit of this effort. There is a slight paint mark, since removed, on the edger just behind the patch. This is amazing!

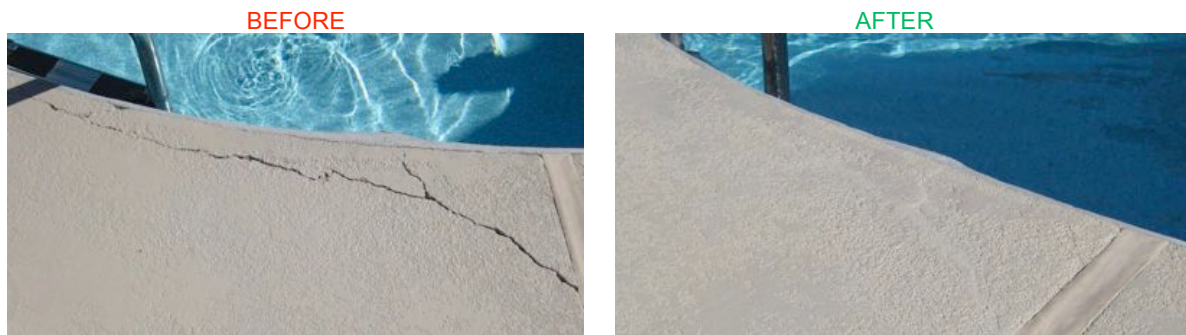
Next, as we move counter-clockwise around the pool, is the area where most of my time and about 40% of the Epoxy Crack Filler Kit was consumed. This hairline to 1/8" wide crack originates at an expansion joint, on the right; and runs to the pool coping behind the ladder. This crack was becoming a great concern because it was at the pool's edge, and also since the pool discharge outlet is to the right of the ladder. Even though this area is covered during the winter, some water obviously enters this crack. Freezing was causing further degradation each winter.

My repair approach was to fill as much of any void, possible, with pure Epoxy Crack Filler (No Sand). Small batches of Crack Filler were mixed using small, plastic, measuring cups. Only enough Crack Filler was mixed, at a time, to halfway fill a squeeze bottle (mustard equivalent). By repeated passes, I was able to fill the entire length of the crack to within 1/2 inch of the surface. Four mixes and passes were required. To achieve final seal, the addition of a small amount of sand to the epoxy mixture was needed for an area about six (6) inches long, near the expansion joint. The repair was completed with a 1:1 ratio of Sand to Epoxy Crack Filler Mix; this was followed by the light sand, sprinkling, technique, as described above. As seen below, the results seem impressive. I am anxious to see what the winter brings.

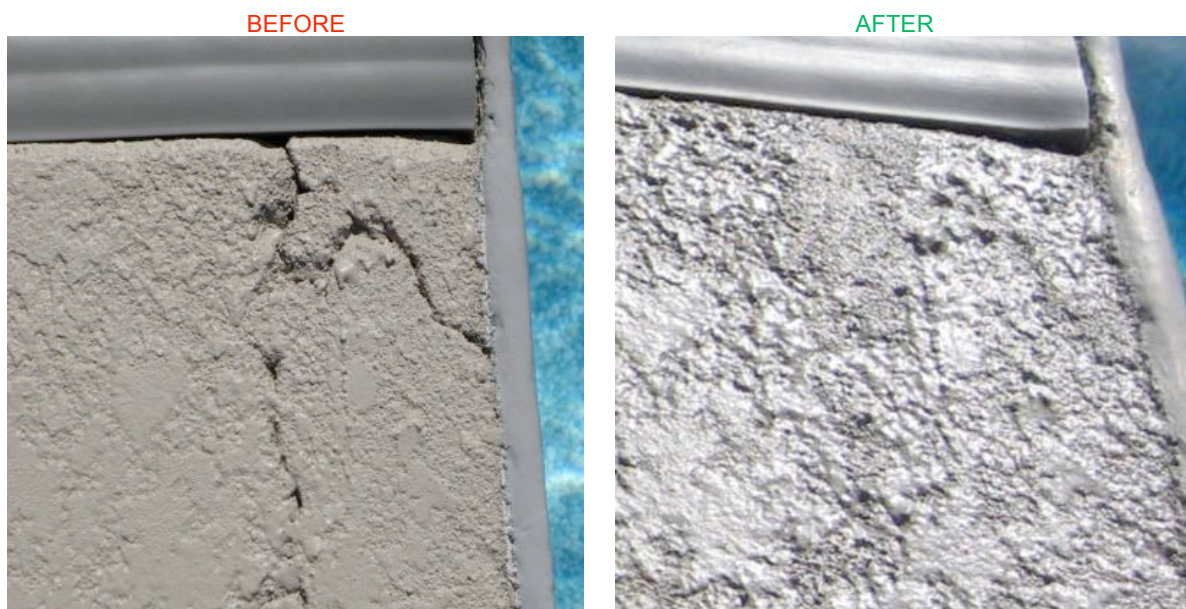
This next area of minor spalls and hairline cracks was a miniature version of the conditions and procedures that are prescribed above. The depth of the cracks was much less severe.

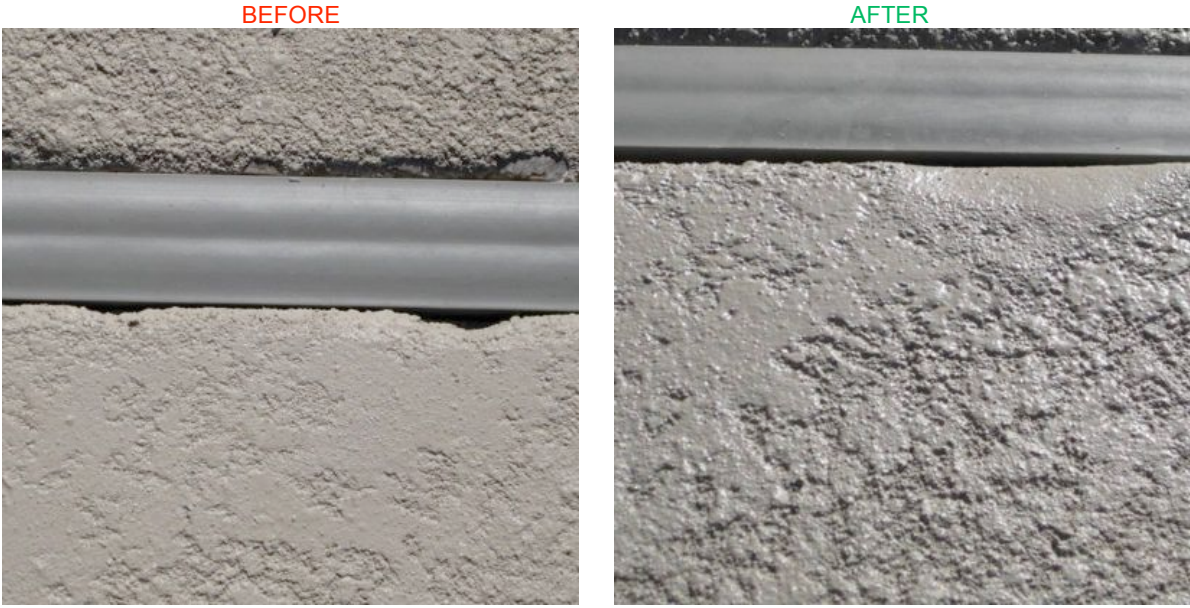
The following two chipped out areas next to the vinyl “SlabGasket” 2”x4” expansion joint were easily patched using the 2:1 ratio of Sand to Epoxy Crack Filler Mix. In hindsight, it may have been slightly better to increase the Sand amount for a 2-1/2 or 3 parts to 1 ratio.

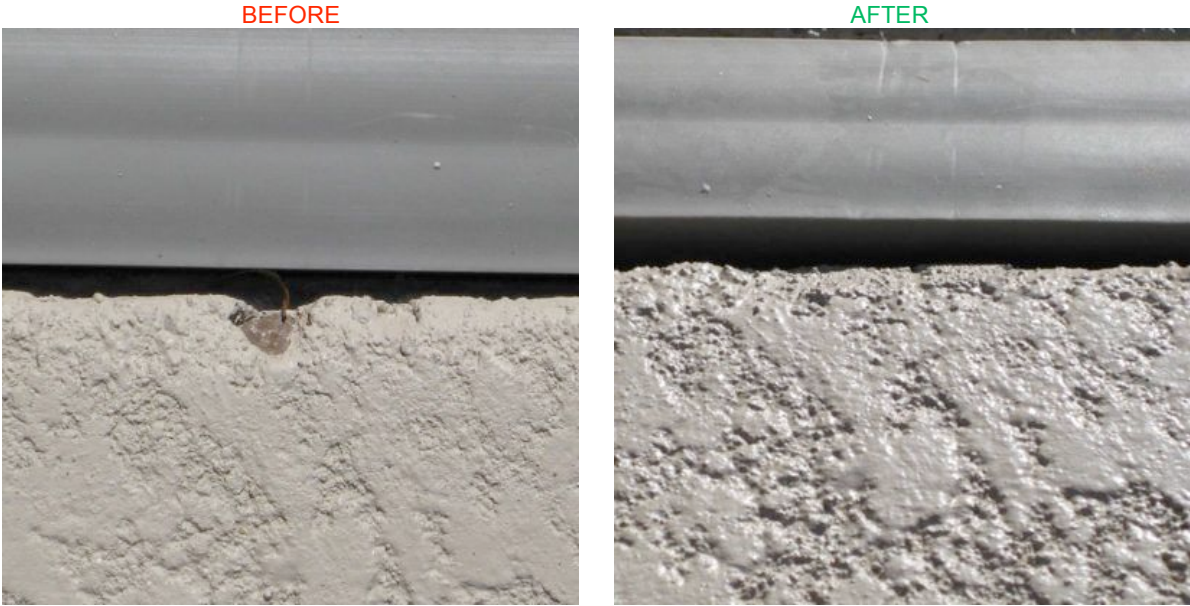
This small breakout was repaired with 3:1 ratio of Sand to Epoxy Crack Filler Mix. It was slightly harder to tool, but the patch held its shape afterwards.

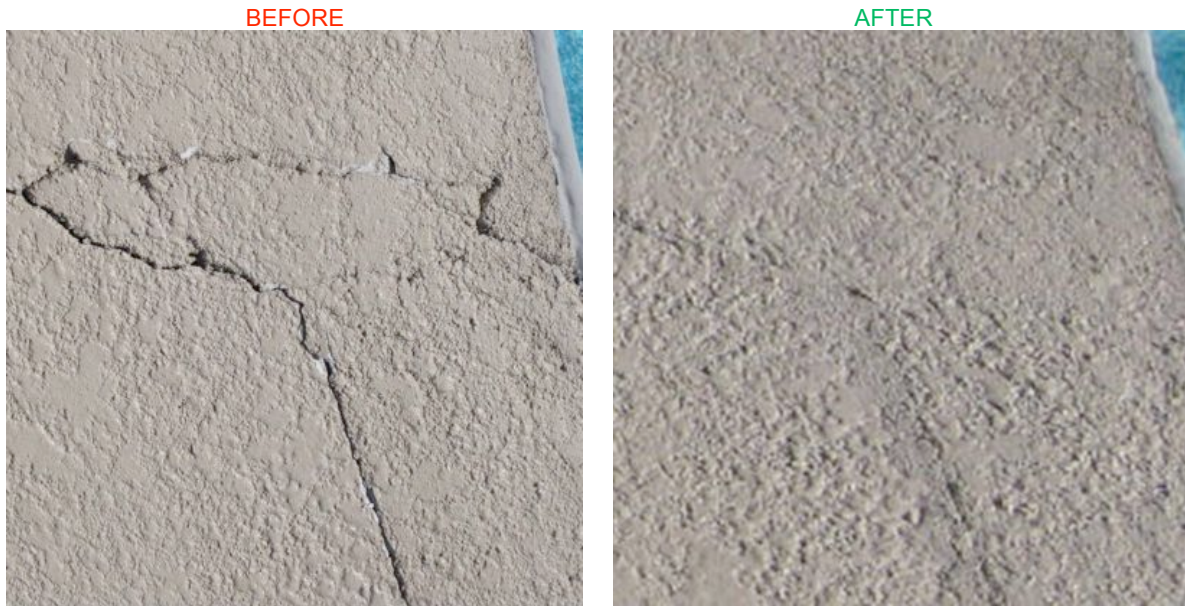
The small area of hairline cracks below is a small portion, near the pool, of a hairline crack that runs for 8 feet from the left side of the first two pictures. This repair was very tedious. Only very small amounts of Crack Filler (No Sand) were mixed at a time; about ½ cup liquid was all that could be easily drizzled into the narrow crack using a 2" wide plastic putty knife. Repeated passes over 1 or 2 foot sections, at a time, were used to fill within ¼" of the surface. This prevented partial curing in a section prior to completion. Roughly One-Half part of sand to Epoxy Mix was then used to fill to the surface. Very light sand was then applied; excess sand was brushed away and removed after 30 or 45 minutes.

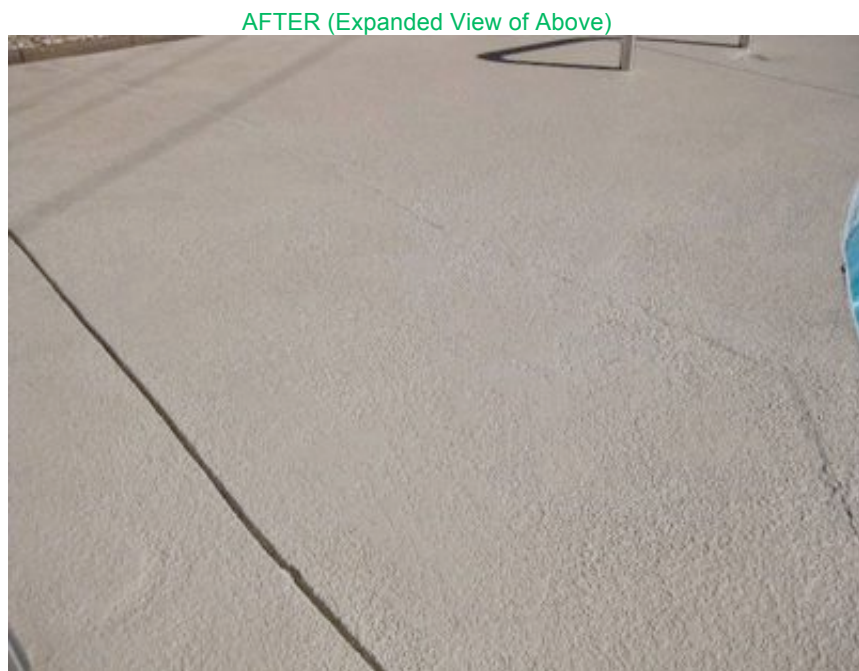
This last photo presents the entire length of the crack described above. It begins near the Pool and extends to the upper left corner of the picture. The photographs above are also seen below as the extreme right, lower half, portion of the frame.
